## SPI™ 25xx080/160 Mode 1,1 Write Operation

Author: Shannon Poulin  
Microchip Technology Inc.

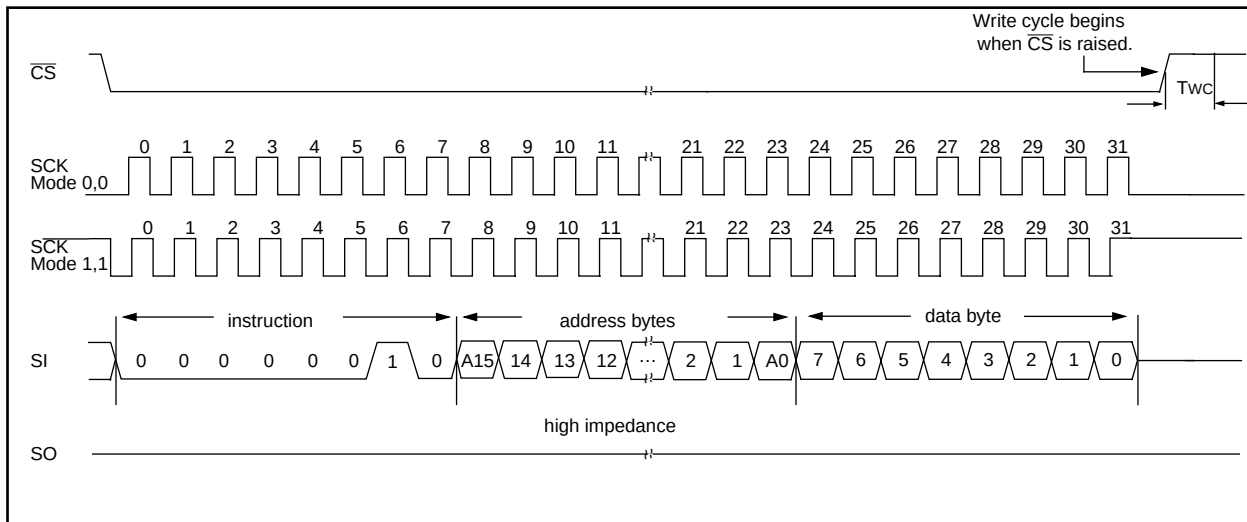
**FIGURE 1: NORMAL WRITE OPERATION**

Figure 1 depicts a write timing diagram. It can be seen that for mode 0,0 operation, the clock line is low when  $\overline{CS}$  is brought high to start the write cycle timer. The write will be completed successfully in this case.

The dashed lines in Figure 1 also depict the state of the clock in mode 1,1. The drawing shows that the clock line will be high when  $\overline{CS}$  is raised. This will not start the write cycle timer, and the part will not write successfully.
