# TB3012

### Conversion of Graphics PICtail<sup>™</sup> Plus Board 2 for Compatibility with USB PICtail Plus and Firmware Modification

Author: Paolo Tamayo Microchip Technology Inc.

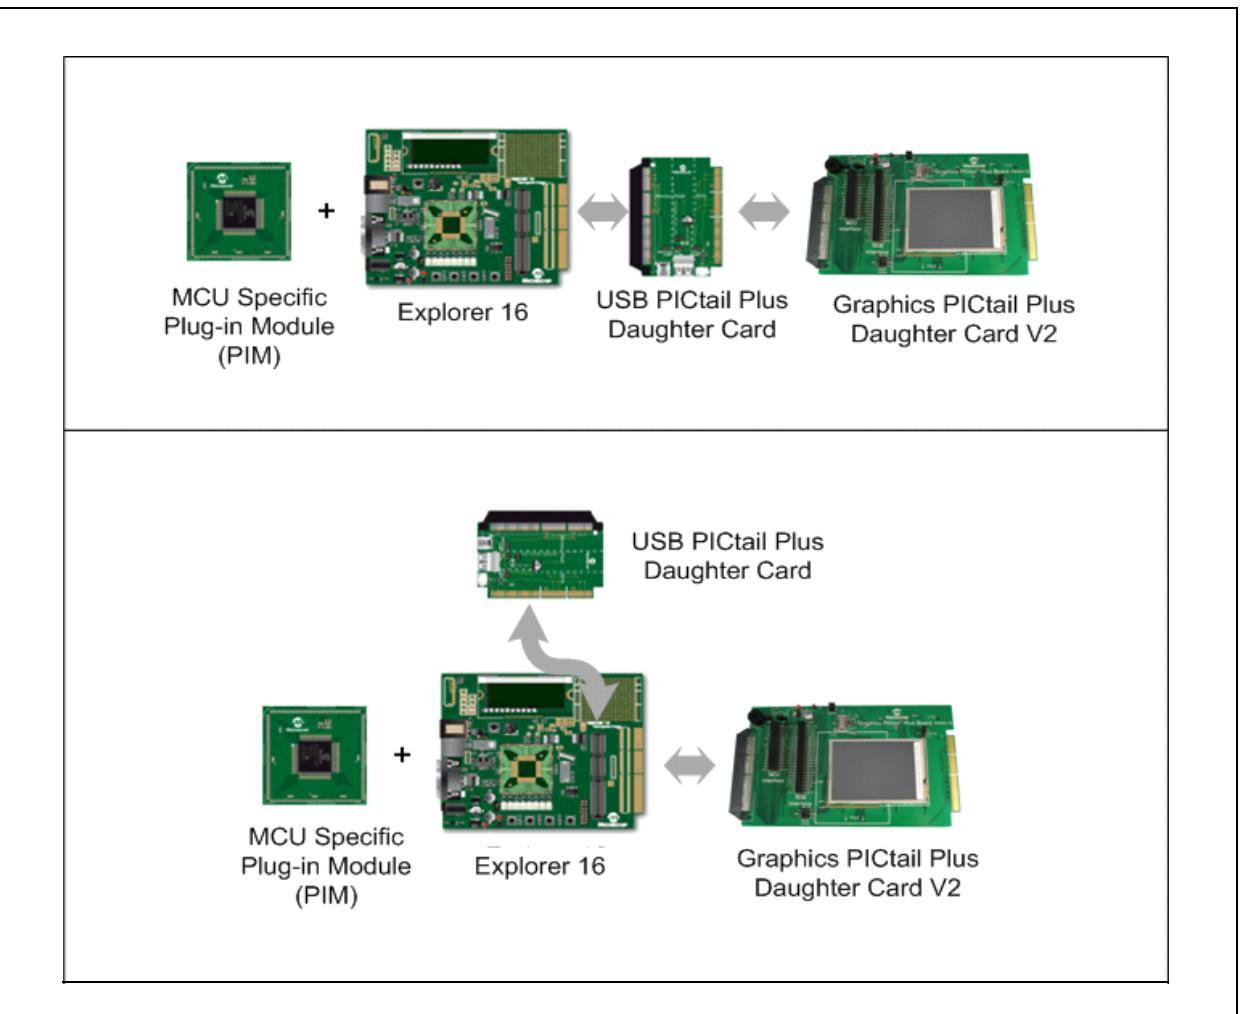
## FIGURE 1: CONNECTION CONFIGURATION WITH MODIFICATION ON GRAPHICS PICtail™ PLUS BOARD

Two possible connections of the three components are shown in the following Figure 1. This assumes the modification on the Graphics PICtail Plus Board Version 2.0 has already been performed on the J1 connector edge (the connector on the left side).

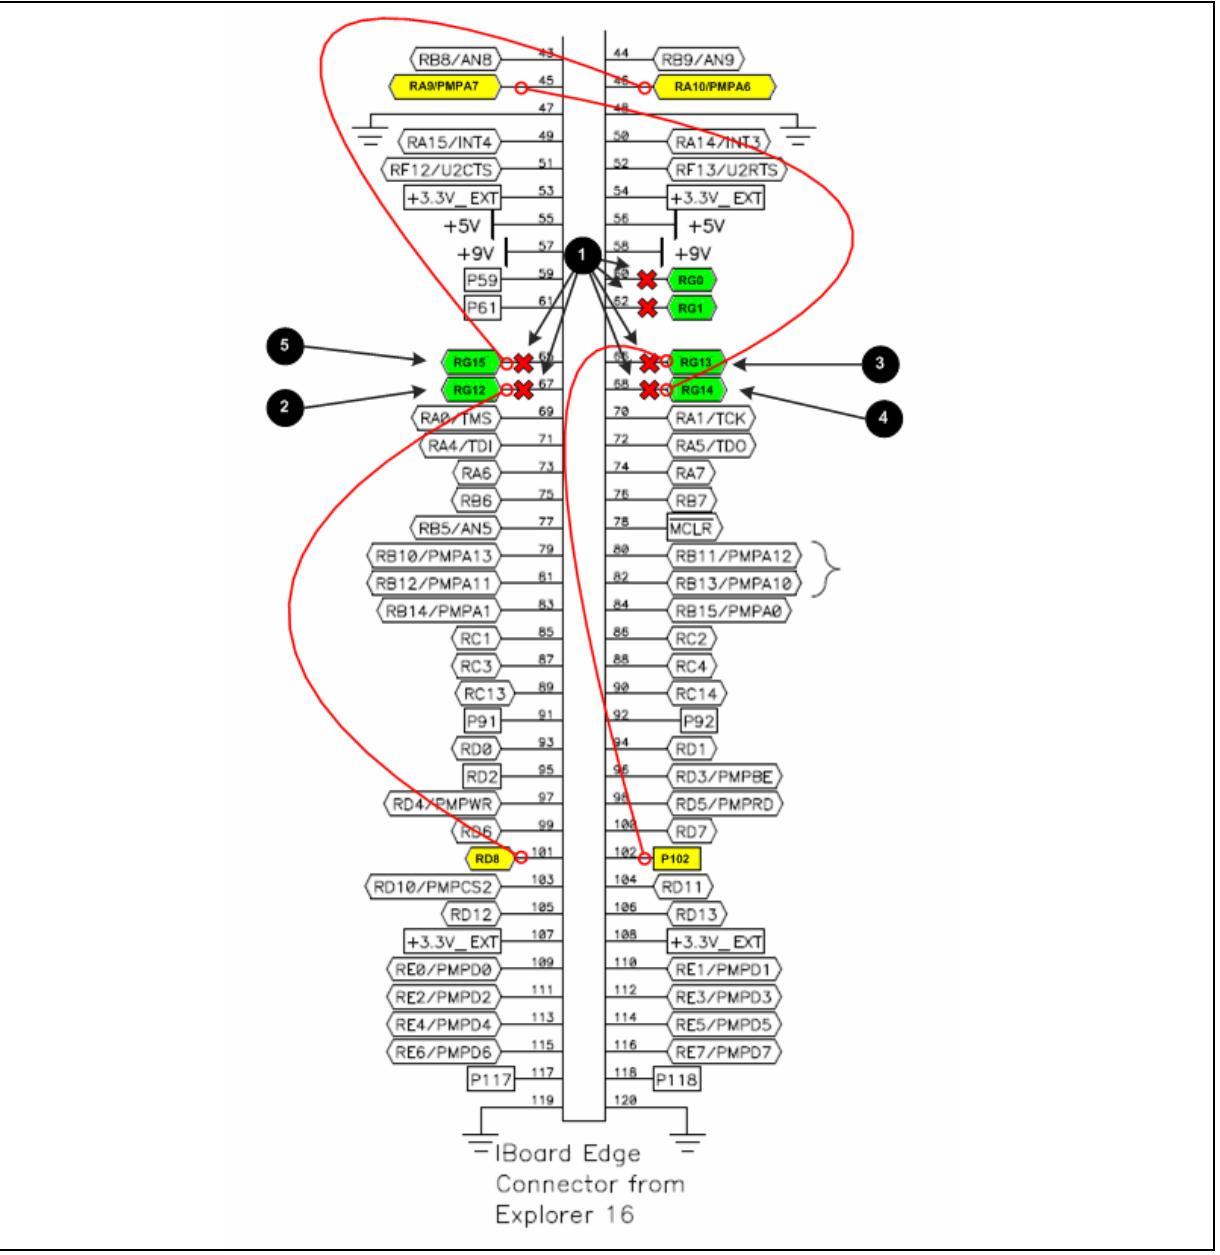
### FIGURE 2: SIGNAL MODIFICATION SUMMARY

The hardware changes needed to modify the Graphics PICtail Plus Board Version 2.0 are relatively easy. They are shown in the layout in Figure 2, with locations corresponding to the steps listed below.

- 1. Cut the signals going into the Graphics PICtail Board to isolate the following signals:
  - a. RG0
  - b. RG1
  - c. RG12
  - d. RG13
  - e. RG14
  - f. RG15

- 2. Connect RD8 signal to RG12 signal.
- 3. Connect RD9 (P102) signal to RG13 signal.
- 4. Connect RA9 signal to RG14 signal.
- 5. Connect RA10 signal to RG15 signal.
